THE CHANGING RAPIDS OF THE COLORADO RIVER

Brown Betty Rapid (Rapid 1)

By Jayne Belnap, Bob Webb
and John Weisheit

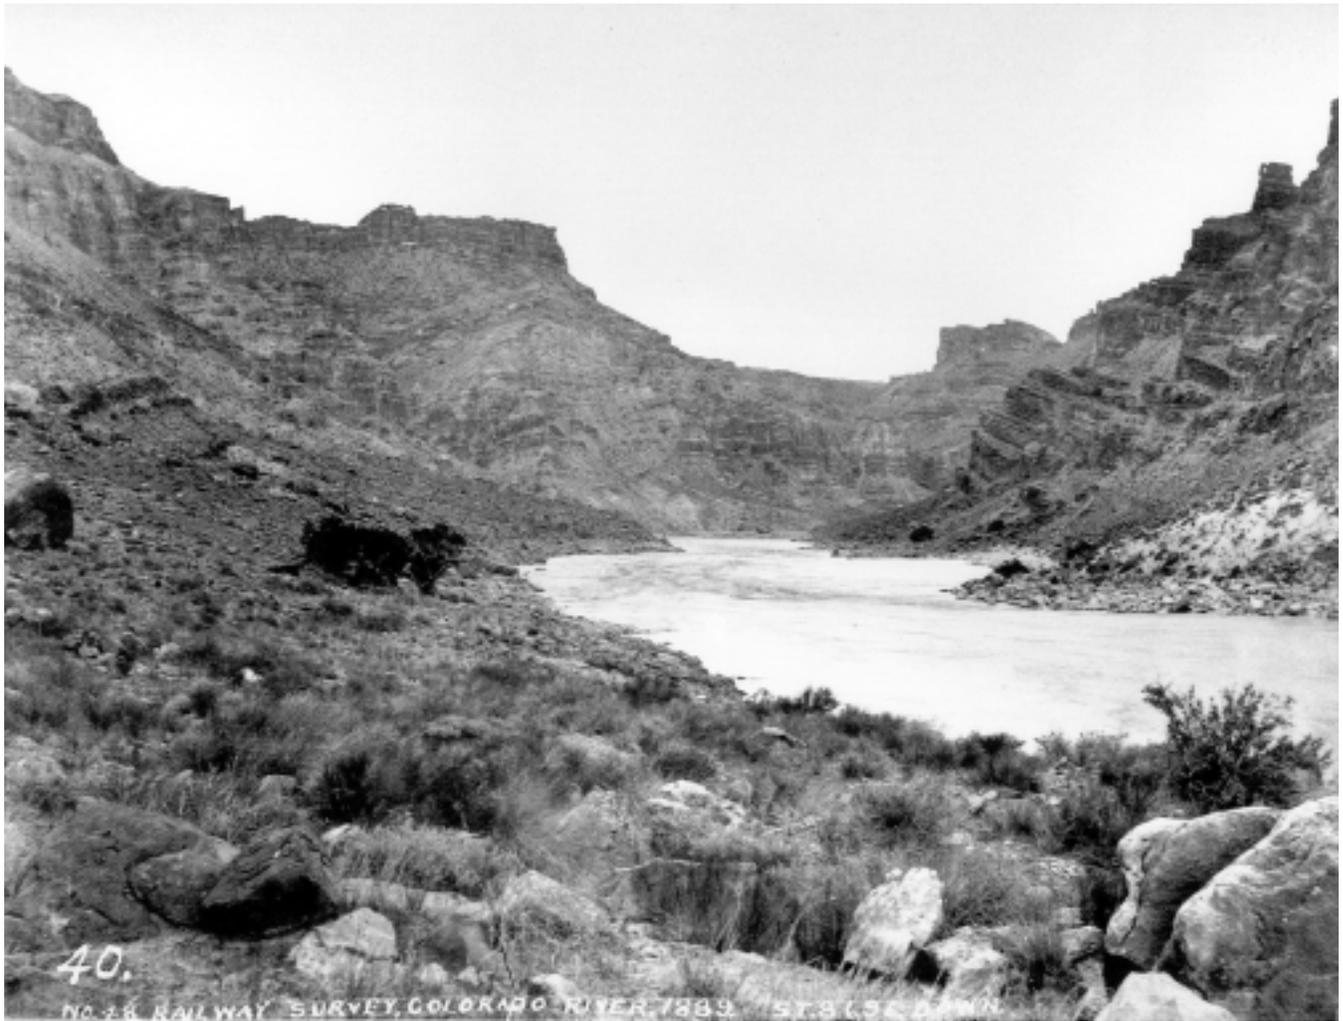
Figure 1. Rapid 1 from River Left. (files s2908-1889.tif and s2908-1994.tif)

A. (May 31, 1889). While Stanton surveyed and Brown ordered the boats carried around rapids, Franklin Nims photographed Cataract Canyon. This downstream view shows Rapid 1 at about 40,000 ft³/s. Shortly after this photograph was taken, the raft attached to the *Brown Betty* was cut loose and swept into the rapid (Nims 40, courtesy of the National Archives).

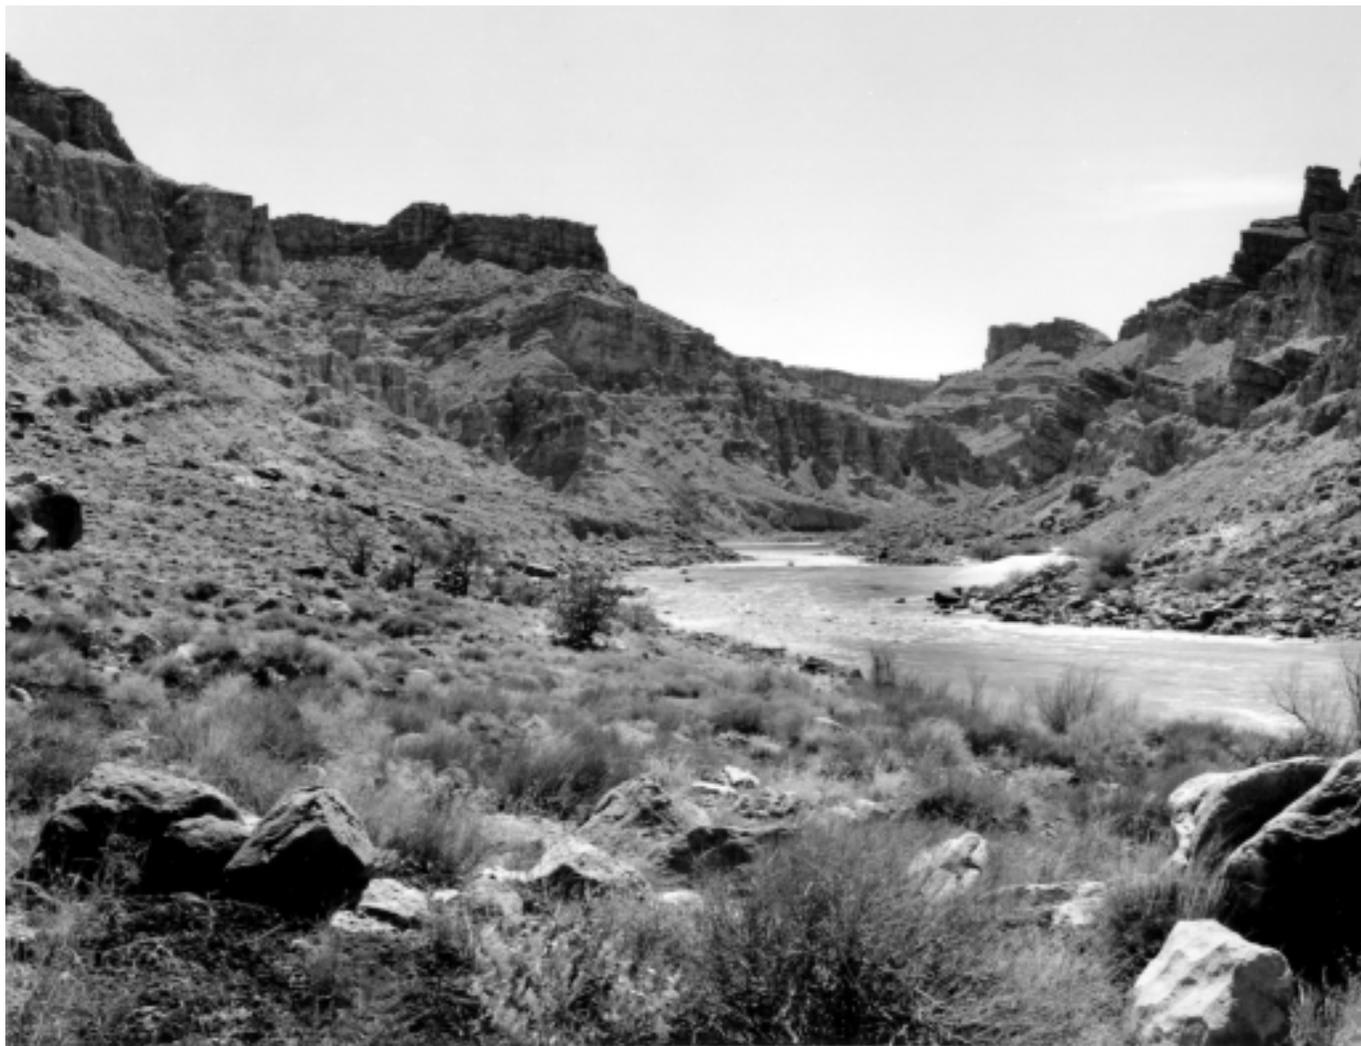
B. (March 28, 1994). Despite the water-level differences, the beach below Rapid 1 is larger now, and tamarisk lines the bank. A debris flow from river right has slightly changed the head of the rapid (Steve Tharnstrom, Stake 2908).

Few river trips, other than the Brown-Stanton expedition, have had problems in Brown Betty Rapid. Most of the early expeditions seemed to run the rapid without troubles. Despite the fact that a debris flow has entered the upper right side of the rapid, little appears to have changed in its hydraulics. The little, thrashing hole that appears at right center at low water (5,000 to 10,000 ft³/s) appears in several early photographs, the few rocks have been moved from the river banks. So, other than a strange and inappropriate name, why would anyone be interested in Brown Betty Rapid?

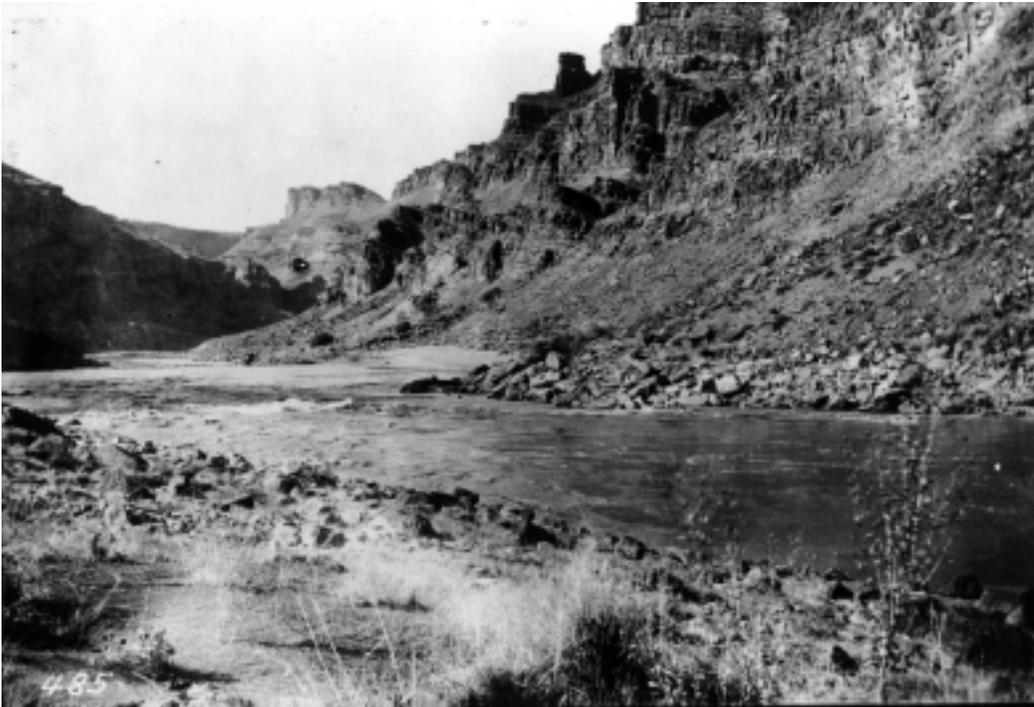
Figure 2. Rapid 1 from river left (files s3575-1909.tif and s3575-1994.tif)

A. (October 18, 1909). The little hole at right center of Brown Betty Rapid is crashing in this view. (Cogswell 485, courtesy of the Bancroft Library, University of California Berkeley).

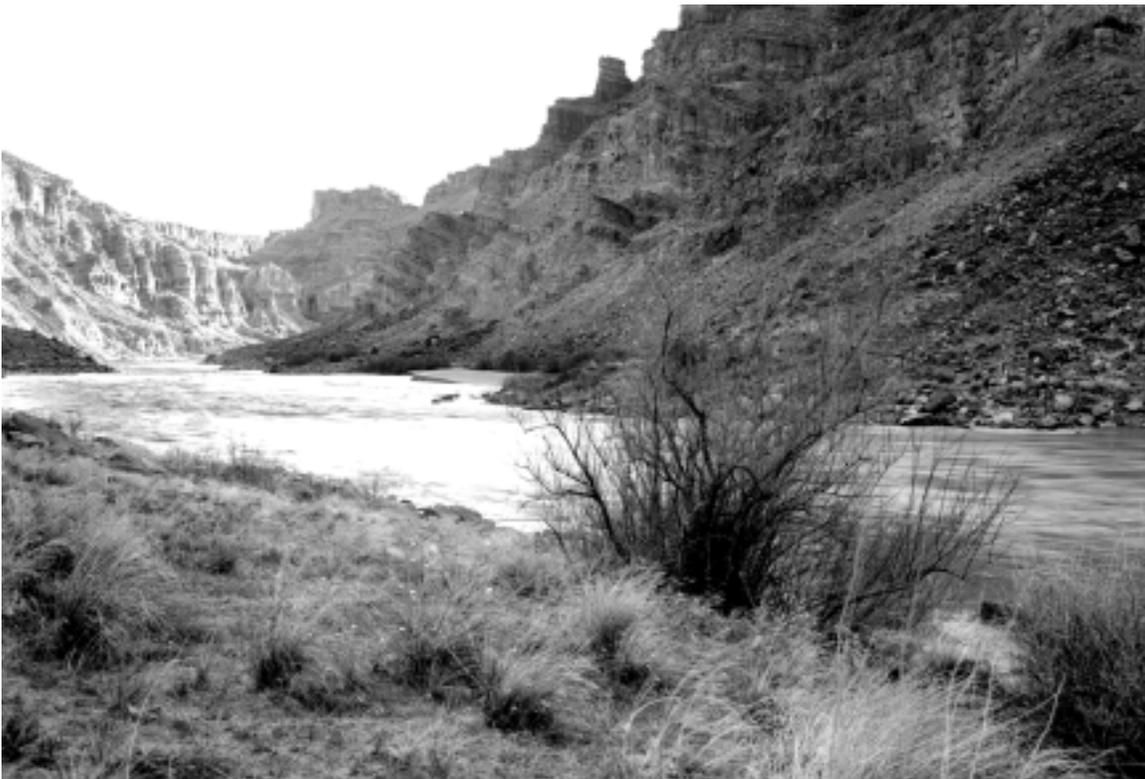
B. (March 30, 1998). The water level is much higher, drowning out the beach. A debris flow has swept into the right side of the rapid, scouring the talus cones and depositing a few new boulders in the river. (Dominic Oldershaw, Stake 3575).
